Influence of the Wash From Bronze on the Weathering of Marble

National Bureau of Standards

Building Materials and Structures Report 137

Daniel W. Kessler and Ross E. Anderson

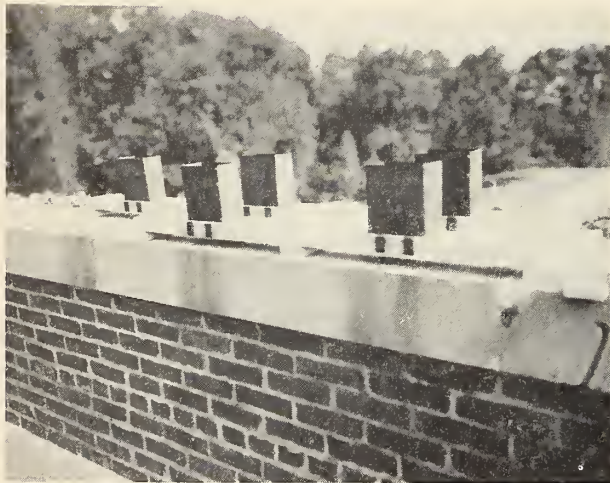
Figure 5 shows some of the specimens exposed on the limestone coping of a building at the National Bureau of Standards. All specimens were freely exposed, with no protection from the weather or sunlight. Each marble slab was supported on strips of marble attached to the limestone with plastic calking material. The marble slabs were attached to the strips in the same way. The bronze shavings were placed in 22-gage phosphor bronze boxes at the center of each marble slab and held in position by strips of the metal passing below the marble. Each box contained 1.8 kg of bronze shavings, and as the boxes were open at top and bottom, rain water could trickle down through the shavings and over the faces of the marble slabs.

FIGURE 5. Some of the specimens in the exposure test and the method used for exposing the marble to the wash from bronze shavings.

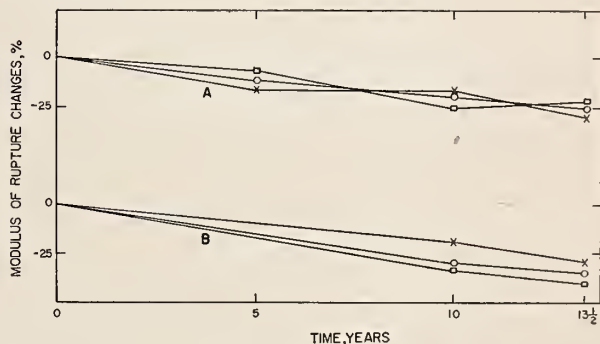
At the end of the 5-year period, the marble slabs were broken only in the middle for flexural strength. At the ends of the other test periods, the strength was determined by loading the specimens first in the middle, then breaking the two end pieces by loading them in the middle. The slabs subjected to bronze wash were discolored green at the center, both on top and bottom, so the tests on the long specimens gave the modulus of rupture in a green area, while the breaks at the quarter points were in regions where the specimens were somewhat brown. The curves in figures 7 and 8 indicate that the loss of strength of the marble was least in the green areas, greater in the brown areas, and greatest in the control specimens.

FIGURE 7. Results of flexure tests after three exposure periods.

The first group of curves show the changes in strength at the center of the specimens (which was mainly in a green area of green discoloration), whereas the lower group shows the strength where the marble was somewhat brown. A, Change at midsection (green areas); B, change at quarter-section (brown areas); O, marble with bronze A; X, marble with bronze B; □, marble with bronze C.

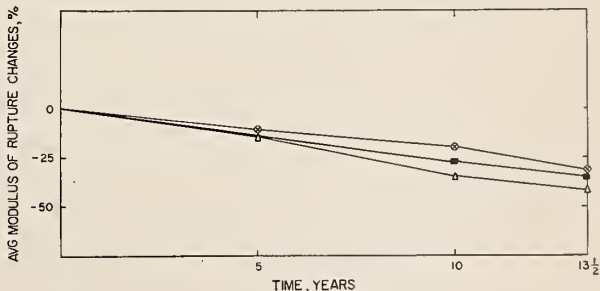
FIGURE 8. Average changes in flexural strength in the brown and green areas, along with changes in this property that occurred in the control specimens.

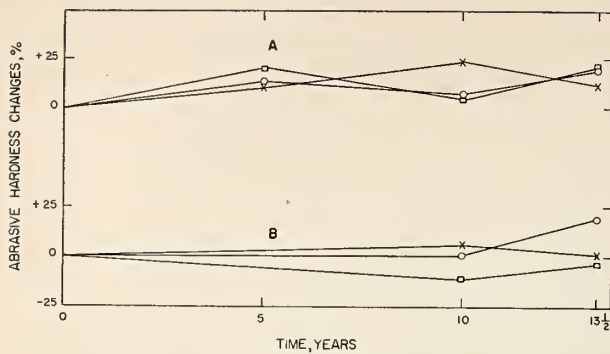
Figures 9 and 10 show the changes in abrasive resistance for different exposures. At the end of the 5-year period, specimens were cut only from the brown areas, but for other periods they were cut from both brown and green areas. The curves are rather variable in trend, but there is some indication that the marble was hardened in the brown areas but not definitely changed in the green. The apparent increase in hardness for five groups of specimens, including the controls at the final tests, can probably be attributed to the variability of the marble rather than an actual increase.

FIGURE 9. Results of abrasive-hardness tests on marble after three exposure periods.

The variability in trends of these curves is believed to be largely due to variability in the marble from one specimen to another. A, Changes in brown areas; B, changes in green areas; O, marble with bronze A; X, marble with bronze B; □ marble with bronze C.

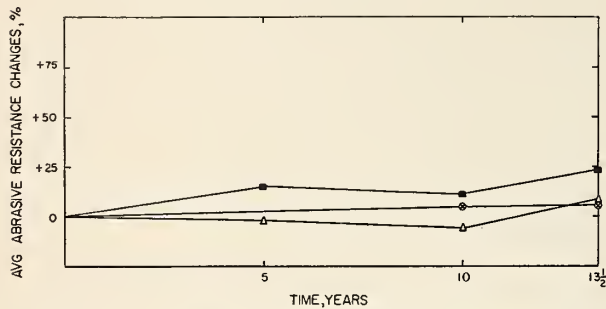
FIGURE 10. Average changes in abrasive hardness in brown and green areas, along with changes in this property that occurred in the control specimens.

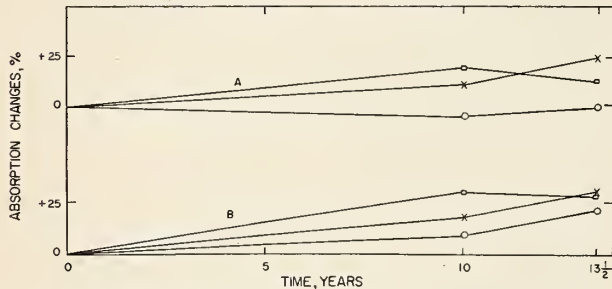
Figures 11 and 12 show that definite increases

in absorption occurred in brown areas for all specimens. In the green areas caused by bronze A the absorption values showed no appreciable change, but in those for bronzes B and C the values were similar to those for the brown areas. All of the increases for the discolored areas were small in comparison with those for the control specimens.

FIGURE 11. Changes in absorption of the marble in brown and green areas for two exposure periods.

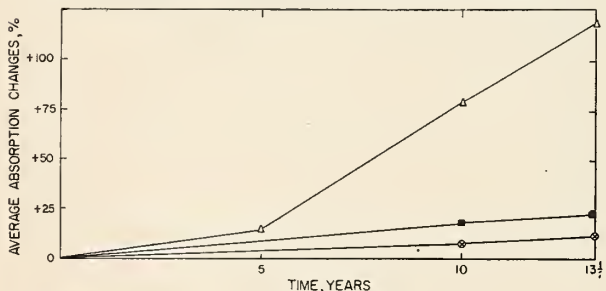
FIGURE 12. Average changes in absorption for brown and green areas, along with the changes that occurred in this property in the control specimens.

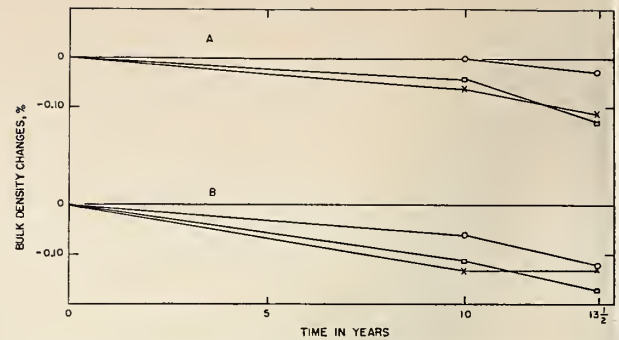
Because the bulk density of the marble was much less variable than other properties, it was expected that the changes in this property would give more reliable indications of weathering than strength, hardness, or absorption. The curves in figure 13 are somewhat more regular in trend than those in figures 9 to 12, inclusive. Decreases in bulk density were more pronounced in the brown areas than in the green, but changes were much greater in the control specimens.

FIGURE 13. Changes in bulk density of the marble for two exposure periods.

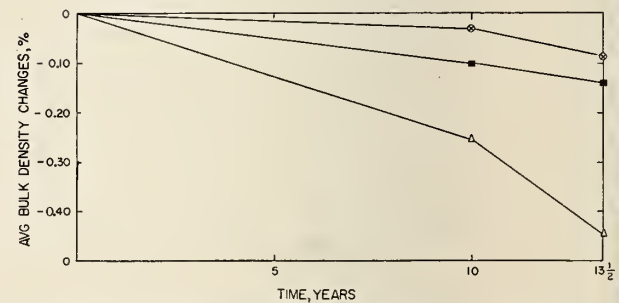
FIGURE 14. Average changes in bulk density for the brown and green areas along with the changes that occurred in this property in the control specimens.
